Pentium® Pro Processor Specification Update

Release Date: March 1998

Order Number: 242689-026

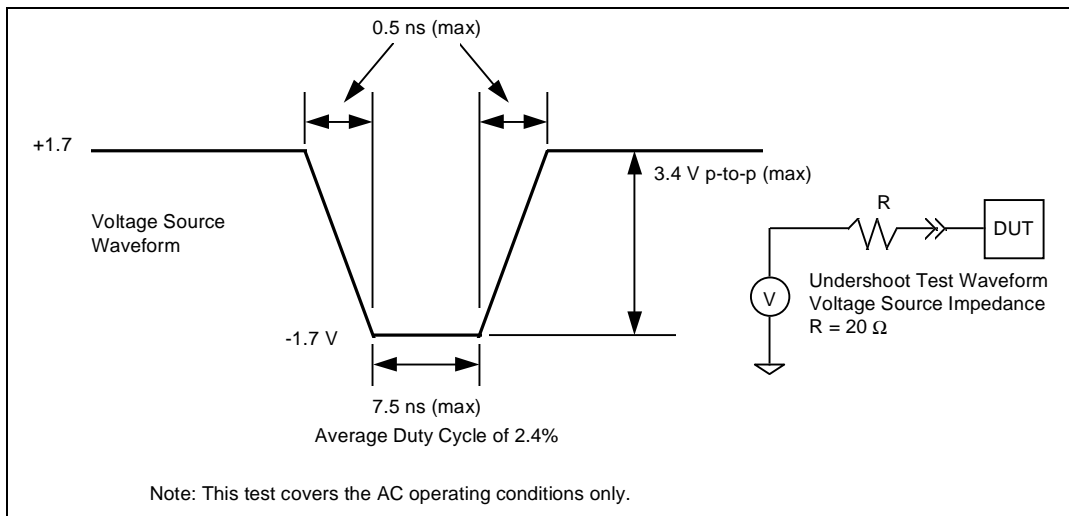
The *Pentium® Pro Family Developer's Manual, Volume 1: Specifications*, Section 11.15., will include the following undershoot specification, to simplify signal integrity issues on signals that can be driven by more than one device simultaneously:

The Pentium Pro processor bus signals AERR#, BERR#, BINIT#, BNR#, HIT#, and HITM# (only) are capable of sinking an 85 mA current pulse at 2.4% average time duty cycle. This is equivalent to -1.7 V applied to a 20Ω source in series with the device pin for 8 ns at 66 MHz with a utilization of 5%.

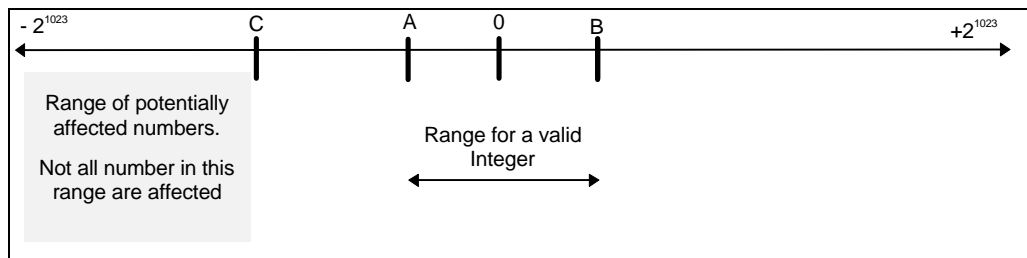
IMPLICATION: Erroneous operation results when the operand is so large that it will not fit into the target data size. The operands affected by this erratum are significantly outside (by a factor of 3X) the range that can be, correctly, converted to an integer value. The figure below and corresponding table identifies the normal range of integer numbers (between A and B) and the starting point of the operands affected by this erratum. Discrete failing operands will be present in the range between point C and the maximum negative number that can be represented by the processor (-21023 in double precision format). Note 2 below gives a qualitative description of the nature of the discrete failing values. Software that does not rely on the Invalid Operation exception flag being set and signaled by either an exception OR by software polling is not impacted by this erratum.

16-bit Operation	A	B	C
	-32,768.0	+32,767.0	< -98304.0
32-bit Operation	A	B	C
	-2,147,483,648.0	+2,147,483,647.0	< -6,442,450,944.0

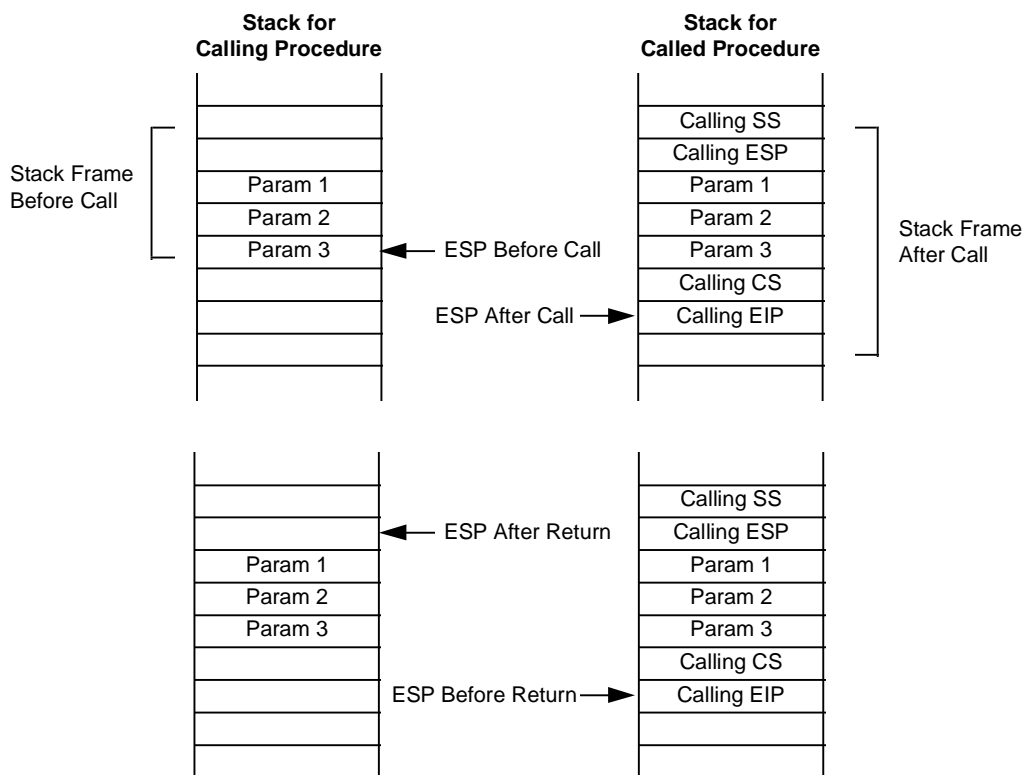
Figure 4-3. Stack Switch on a Call to a Different Privilege Level

When making a call to a more privileged protection level, the processor does the following (see Figure 4-3):

4. Restores the SS and ESP registers to their values prior to the call, which causes a switch back to the stack of the calling procedure.
5. (If the RET instruction has an optional *n* argument.) Increments the stack pointer by the number of bytes specified with the *n* operand to release parameters from the stack (see explanation in step 3).
6. Resumes execution of the calling procedure.

Note: On a return, parameters are released on both stacks if the correct value is given for the *n* operand in the RET *n* instruction.

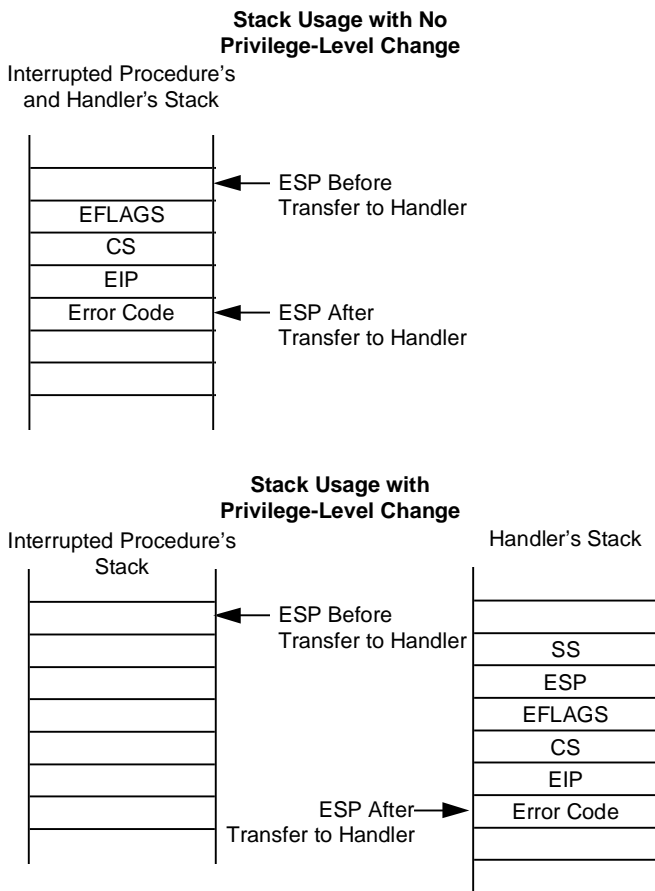
Figure 4-4. Stack Usage on Transfers to Interrupt and Exception Handling Routines

When executing a return from an interrupt or exception handler from a different privilege level than the interrupted procedure, the processor performs these actions:

1. Performs a privilege check.
2. Restores the CS and EIP registers to their values prior to the interrupt or exception.
3. Restores the EFLAGS register.
4. Restores the SS and ESP registers to their values prior to the interrupt or exception, resulting in a stack switch back to the stack of the interrupted procedure.
5. Resumes execution of the interrupted procedure.
